American Energy Systems, Inc.

TECHNICAL BULLETIN

MagnuM Baby Countryside & Winchester AC/DC Models

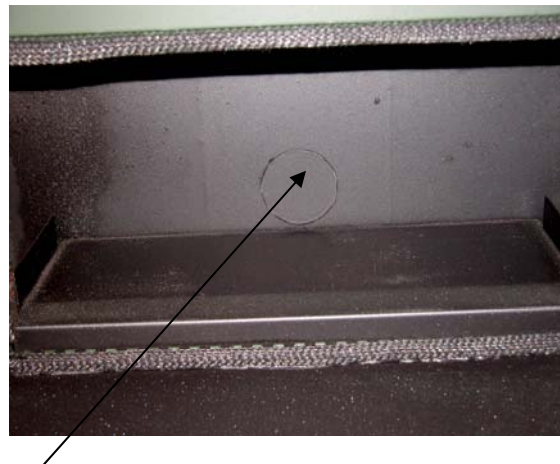
Check to see if plug is loose. If so, remove with
screwdriver and discard this plug. Replace with
new one. Part# RP2094

1. Cleanout plug on the side of exhaust manifold:
 - a. Open right side panel of unit. (facing the front of the unit)
 - b. Remove cleanout plug with screwdriver and discard.
 - c. Insert new cleanout plug (Part#RP2094) (supplied by dealer)
 - d. Plug power back into unit and re-light.
2. Cleanout plug in back of ash pan housing:
 - a. Open door for ash pan. Remove ash pan
 - b. Check clean out plug, if loose remove, discard and insert new one (Part# RP2094) you can get these from your nearest dealer.
 - c. Plug power back into unit and re-light.
