Auger Delron Bushing between Auger and Auger Plate

Product Models Covered: ALL MagnuM Baby Countryside & Winchester models

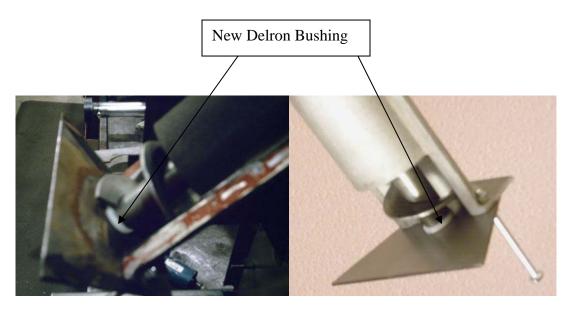
What to look for: There has been a new delron bushing with a longer flange that extends toward the auger motor installed between the auger and auger plate. This is to help alleviate the play between the auger and auger plate so that the bushing does not fall out of the plate.

You will be able to tell if you have an upgraded delron bushing by looking at the serial number, located on the back of the unit. If the serial number is greater than # 13870 (for the MagnuM Baby Countrysides) you have the upgraded delron bushing in the unit. There is no need for current owners to upgrade to the new delron bushing, however if they want to upgrade they can purchase it from their local dealer. The part number is P1178
