AES Technical Bulletin **Auger Sliding Forward**

Product models covered: All models of Biomass/Corn/Wood pellet Magnum appliances using the old style coupler that allowed the auger to be pulled out without disconnecting from the auger motor.

Topic: This technical bulletin will be addressing augers sliding forward, what can cause it, and how repairs are handled so that normal operation can be resumed.

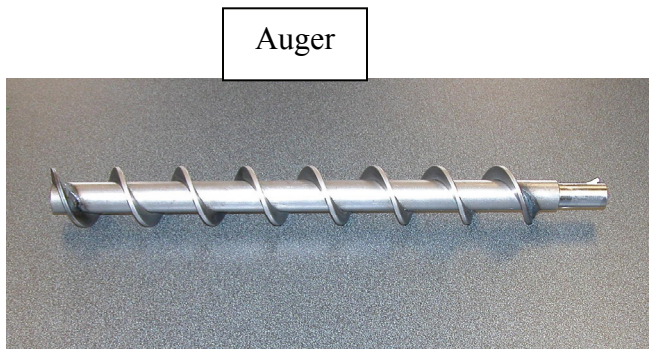
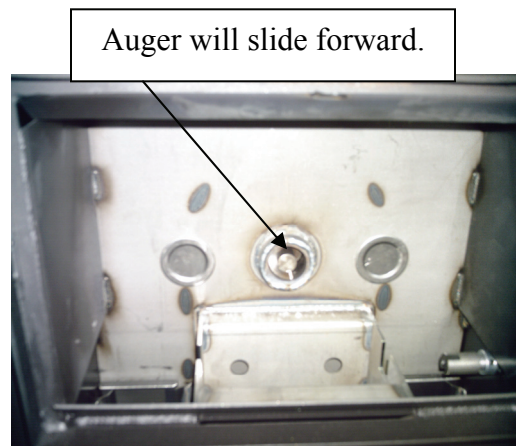
The auger will not slide forward unless something happens to the auger system to cause this to happen. If the auger kicks forward this can be caused by the following:

- The auger is catching on a burr in the auger housing. This can be corrected by honing/sanding the auger housing. (see Technical Bulletin T-0031)
- The housing is nicked from rocks, bolts, etc. being run through the auger system. This can be corrected by honing/sanding the auger housing. (see Technical Bulletin T-0031)

- The auger is bent from something getting caught in the auger such as rocks, bolts, etc. The auger will need to be replaced if it can not be straightened. (to verify the correct auger see Technical Bulletin T-0050)

- The hopper is being run out of fuel and when filling the hopper the auger is being slid forward until it is almost disconnected. Then when the unit is operated the auger slips forward even more. This is corrected by being careful when loading the hopper and repositioning the auger so that there is more drag on it. (Contact you local dealer or technician for this service.)

- The fuel is wet and dirty and this causes the auger to move forward. This is corrected by using dry, clean quality fuel.
- The auger motor was mounted incorrectly. If one side of the motor has more tension than the other, it will put pressure on the auger. (Contact you local dealer or technician for service.)
