## AES Technical Bulletin

### Auger Housing ‘Lip’

**Product models covered:** MagnumM Baby Countryside and MagnumM Winchester

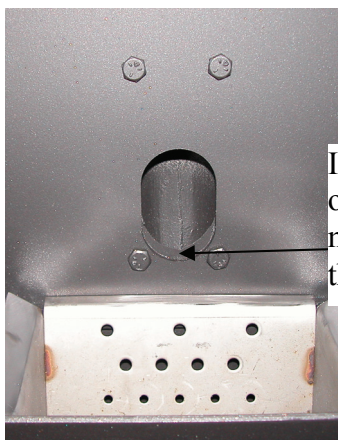
There is a ‘lip’, about 1/8 inch, at the end of the auger housing. American Energy Systems has manufactured this intentionally; it allows the fuel to spread throughout the firepot, for a more even burn. Sometimes the fuel may bounce too much or even out of the firepot. If there is a large amount of fuel that is building up outside of the firepot, the lip can be ground down just a little, to stop the fuel from bouncing out of the firepot. But, remember this lip is there for a purpose, so only grind a little off. Always have a certified technician perform these services.

If fuel is bouncing out of the firepot too much, grind down this lip slightly.
